CARLTON HOUSE CONDOMINIUMS

NEW HIGHLAND BEACH INSPECTION REQUIREMENT

JUNE 27, 2022

Re: Carlton House Condominiums
New Highland Beach Inspection Requirements

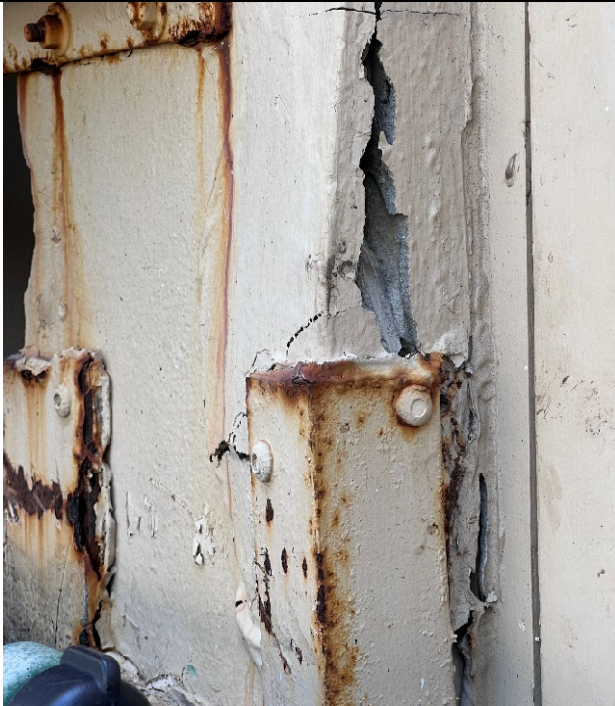
Photo #3:

Spall concrete at exterior wall.

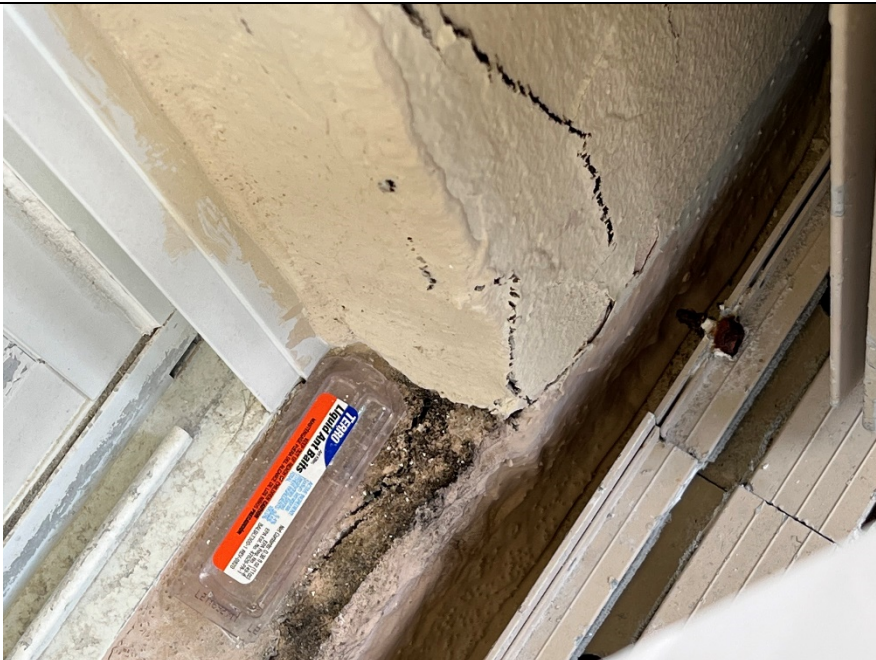
Photo #4:

During our walk-through of the structural building, we physically sounded with our delaminating tool the walls and observed multiple areas of debonding stucco as well as concrete spalling. This may occur due to the stucco losing its bond to the concrete and allowing moisture to penetrate

the concrete, resulting in spalling. Some hairline cracks were also observed but they were all in sound conditions. We recommend that the vertical wall repair be performed by an experienced contractor and the walls be repainted and coated once all the repairs have been completed.

Vertical spalling

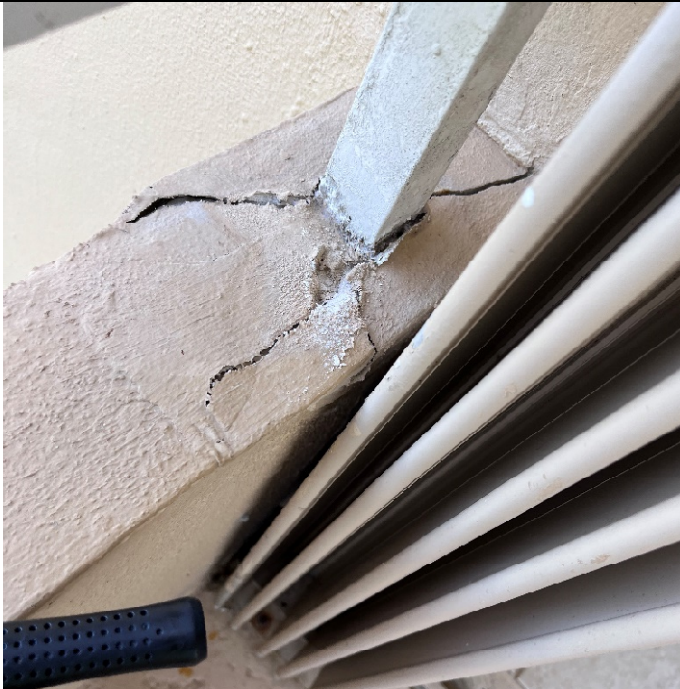
Photo #5:

The balcony guardrails at Carlton House Condominiums are comprised of partial height stucco masonry walls with horizontal aluminum rails on top. The aluminum horizontal guardrails are in generally in sound condition. We observed forty-five of the post grout pockets in the catwalk and balcony to be in poor condition and are loose. It appeared that the grout at the post base had deteriorated and the concrete surrounding the post base had deteriorated as well as the grout.

Spall at concrete at grout pocket

We recommend the concrete be repaired at the post bases where it has deteriorated, and the post has become loose. The grout at the post bases that has deteriorated should be removed and replaced with new non-shrink, high-strength grout suitable for use in an exposed environment. New fasteners should be installed at locations where fasteners have been lost.

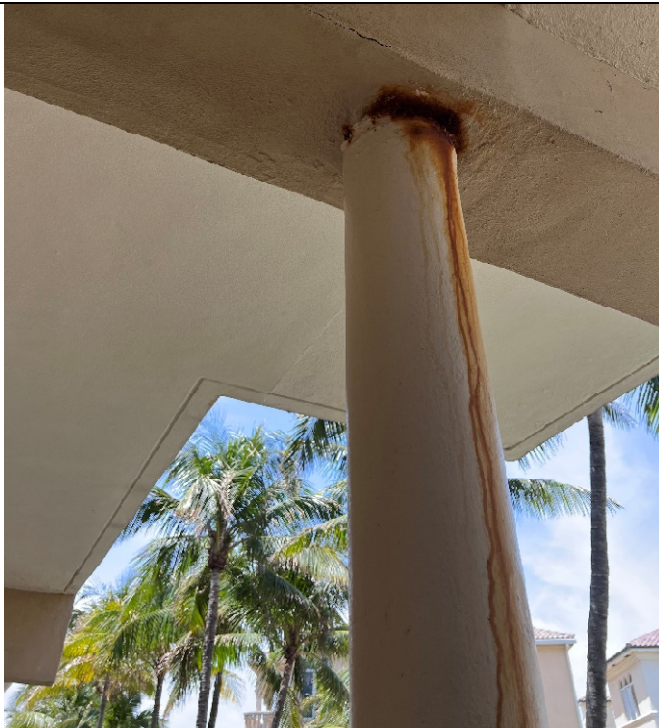
Photo #6:

The condominium has structural steel post located at some of the balconies and at the north and south elevation of the staircase. We observed steel post corrosion occurring at the following balconies: 46,45,36,26,16,15. Corrosion occurs due to the presence of moisture and oxygen, and as well the building exposure to harmful effects of the salt laden sea air is most prevalent. Furthermore, it should be repair because it can affect the condition of the concrete and infiltrate water and deteriorate the reinforcement steel and lead to spalling. We recommended that this is done by qualified restoration contractor per industry standards.

Corroded steel post
