JUNE 27, 2022

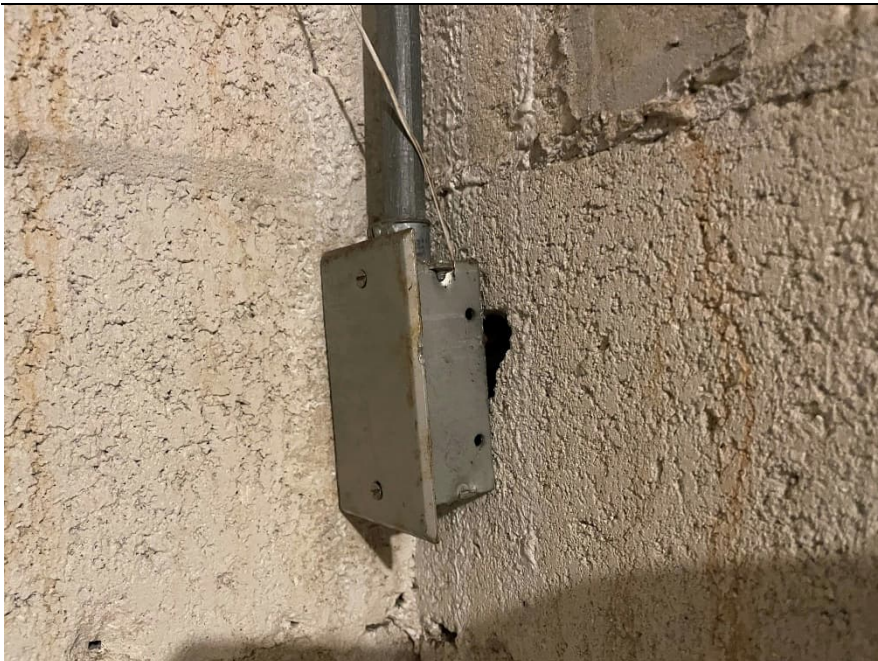
Photo #1:

South Electrical/Meter Room – Fire caulk all penetrations at walls & ceiling.

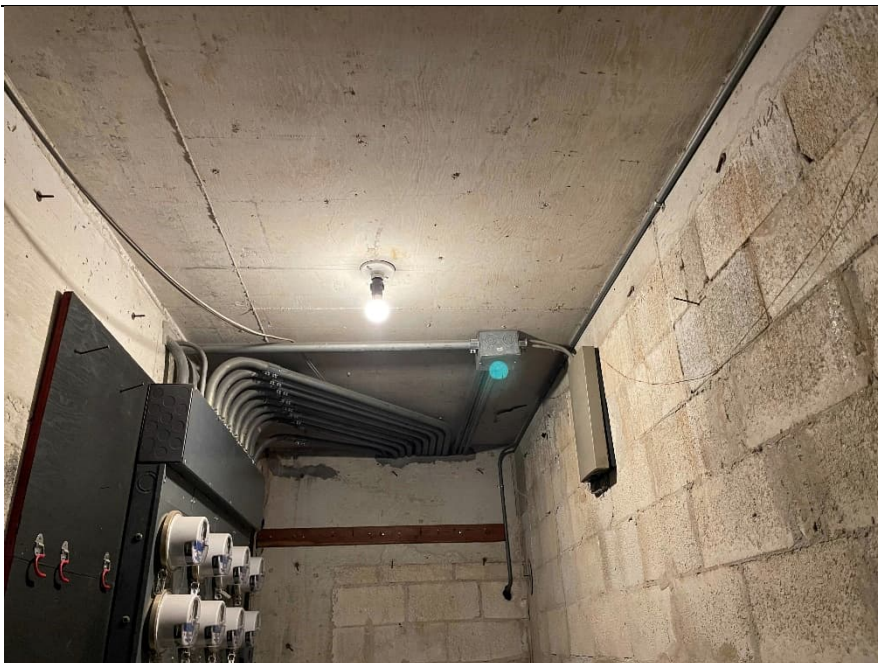
Photo #2:

South Electrical/Meter Room – Smoke detector should be installed.

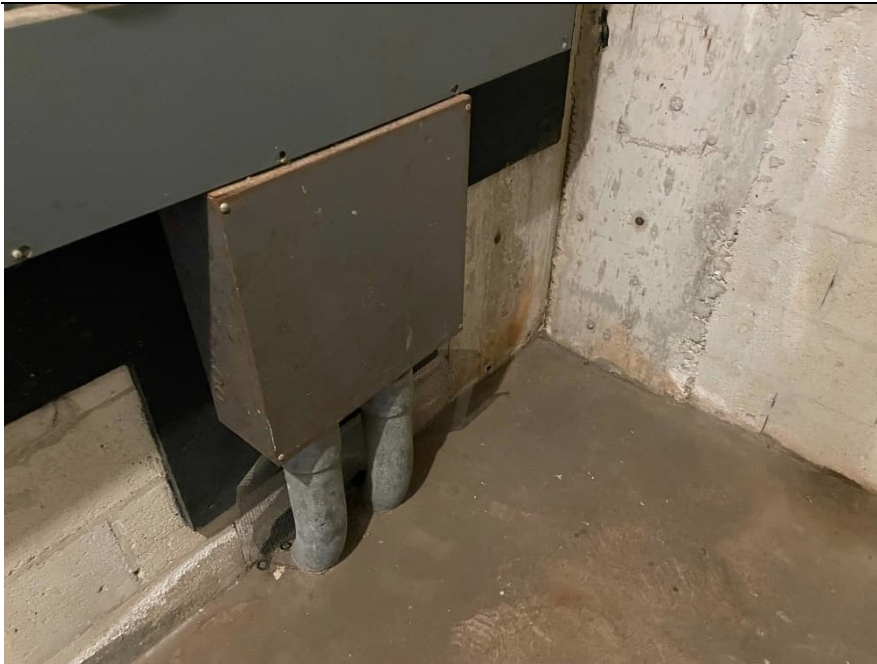
Photo #3:

South Electrical/Meter Room – bottom raceway is severely rusted, needs to be replaced.

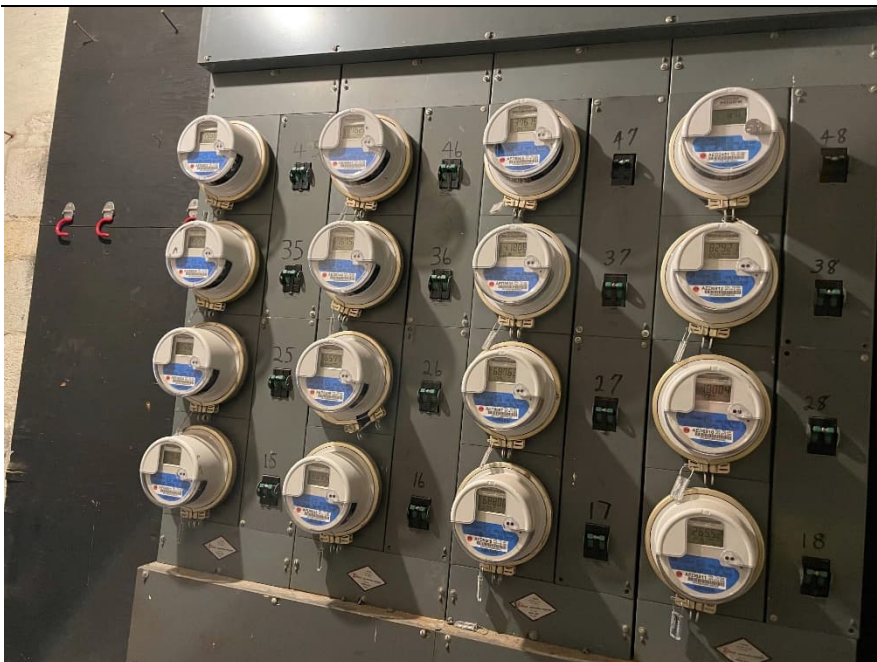
Photo #4:

South Electrical/Meter Room – All Zinsco equipment must be tested.

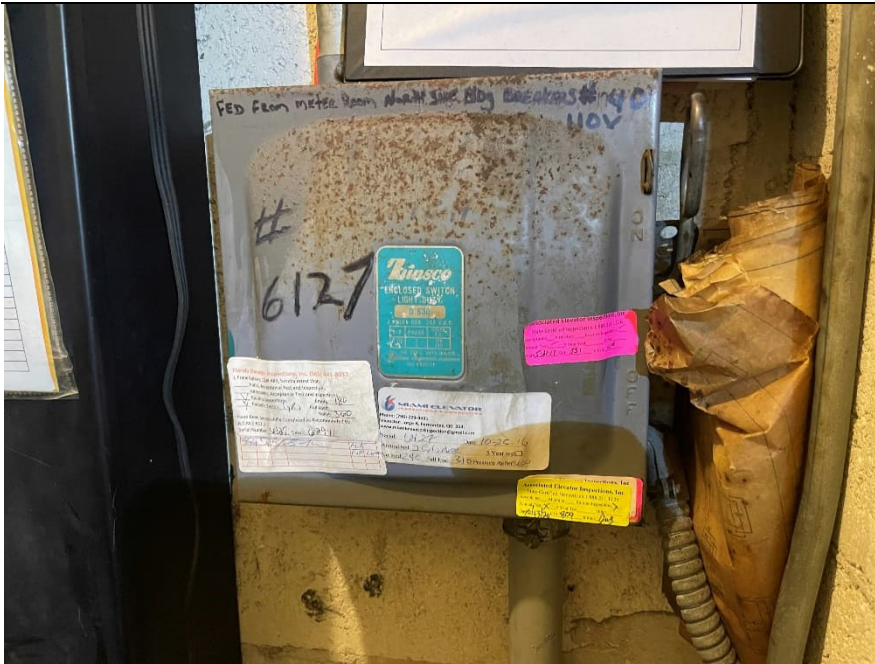
Photo #5:

South Elevator Machine Room – Rusty Zinsco Disconnect Switch should be replaced.

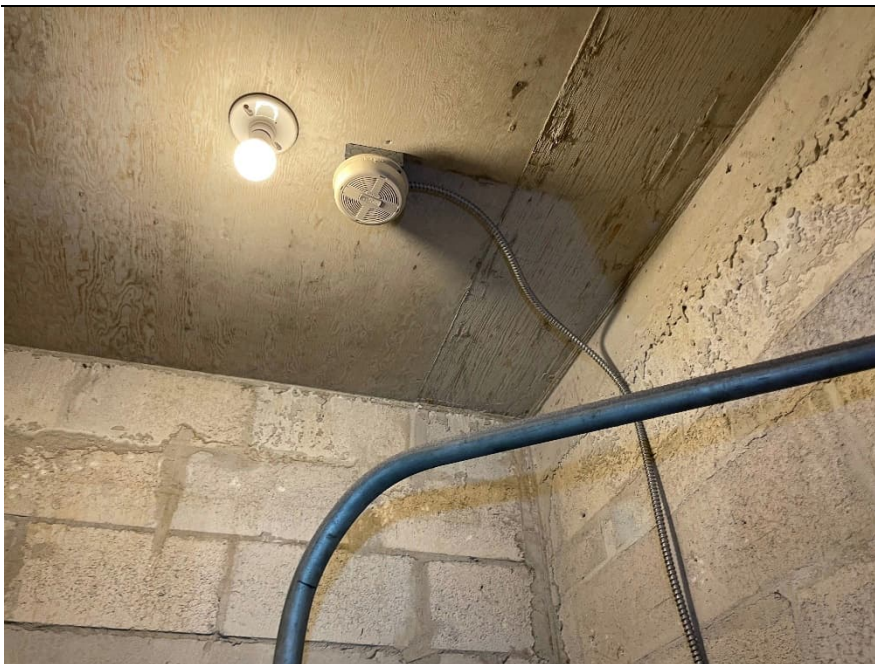
Photo #6:

South Elevator Machine Room – Make sure the installed smoke detector is connected to the existing fire alarm system. If it's a single station smoke detector (local individual detection/alarm) remove it and have an addressable smoke detector installed connected to the fire alarm system.

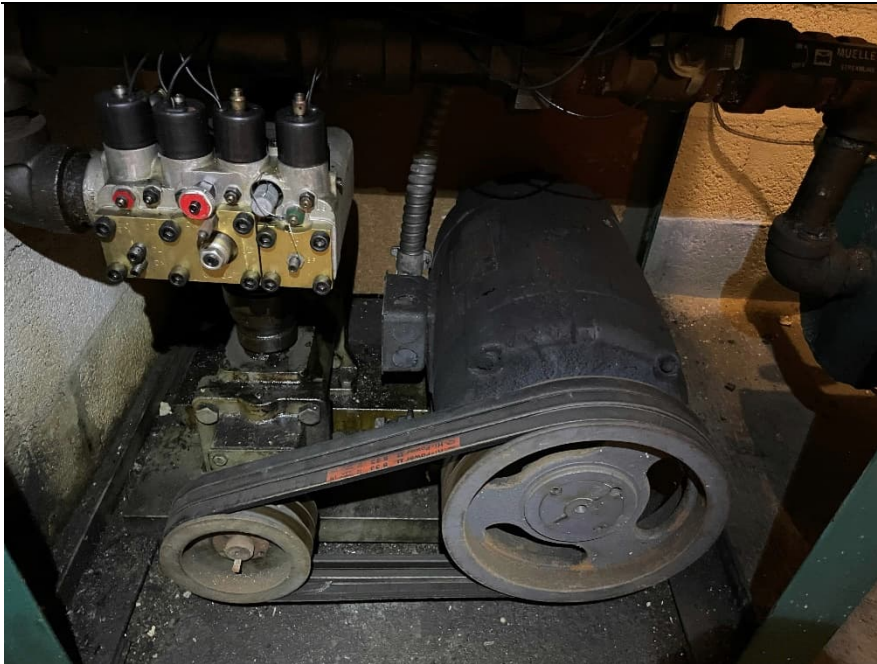
Photo #7:

South Elevator Machine Room – Elevator motor is leaking oil and needs identification.

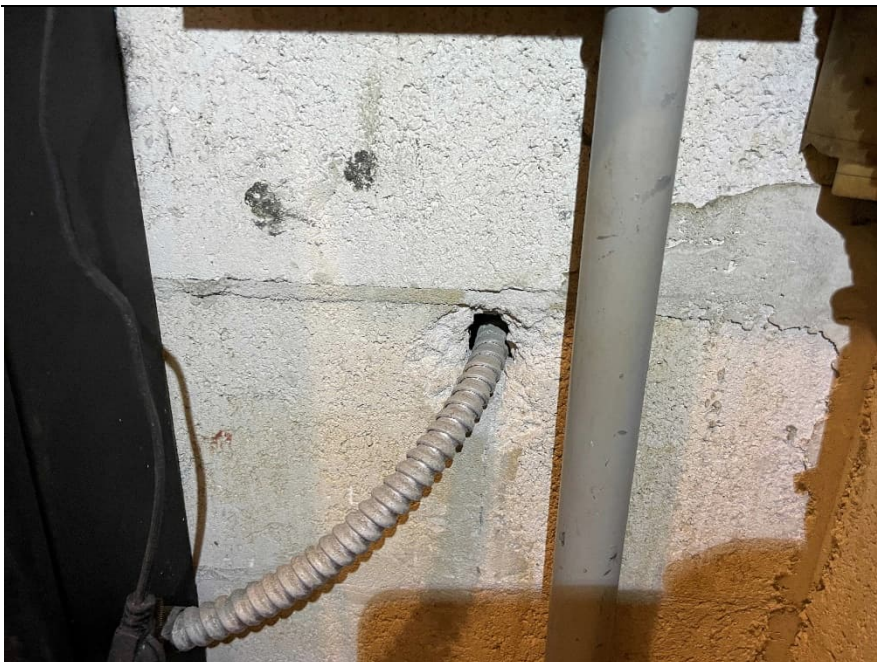
Photo #8:

South Elevator Machine Room – Fire caulk all penetrations at walls & ceiling.

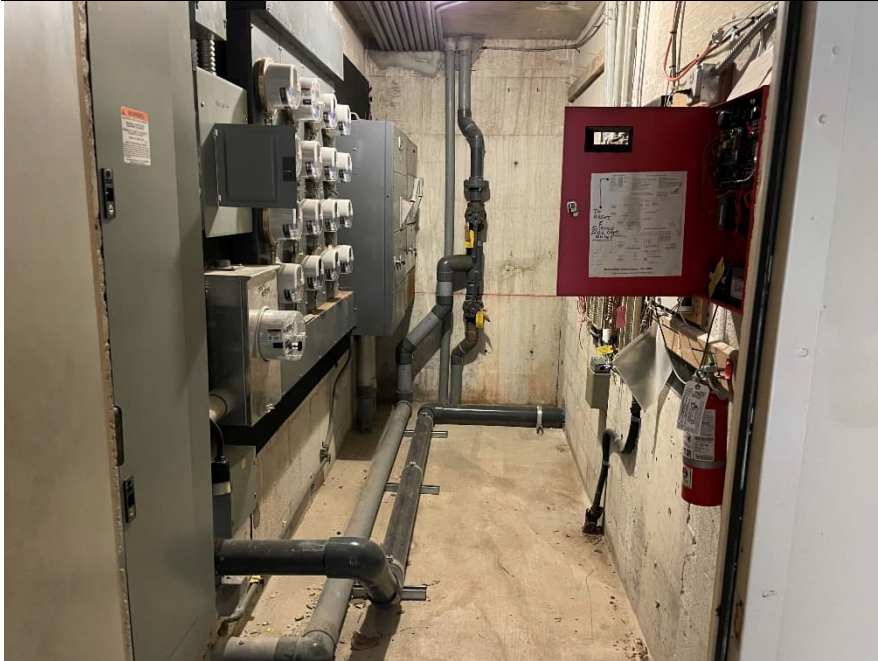
Photo #9:

North Electrical/Meter Room – All Zinsco equipment must be tested. Install smoke detector connected to the existing fire alarm system. Fire caulk all penetrations at walls & ceiling.

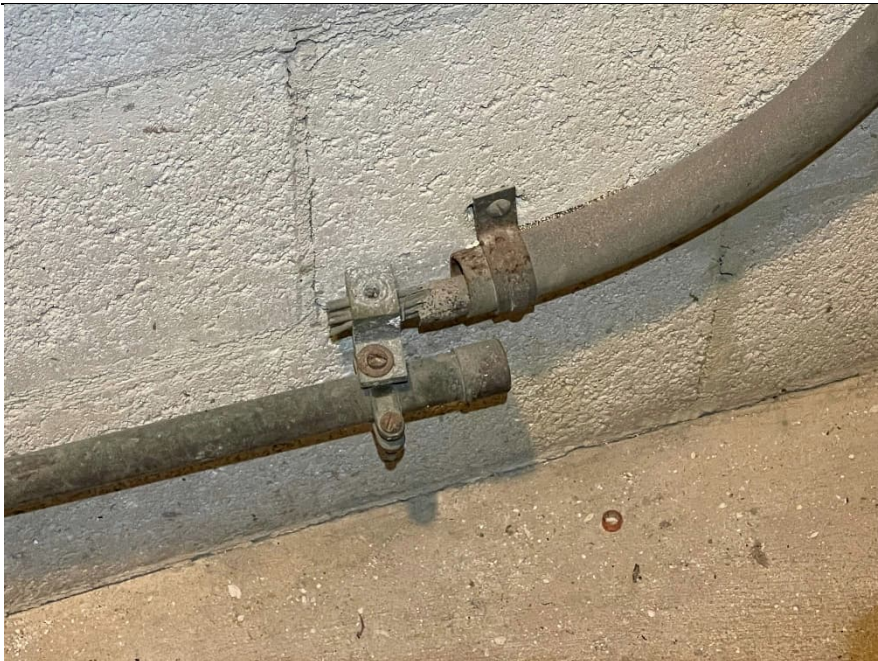
Photo #10:

North Electrical/Meter Room – Grounding needs maintenance.

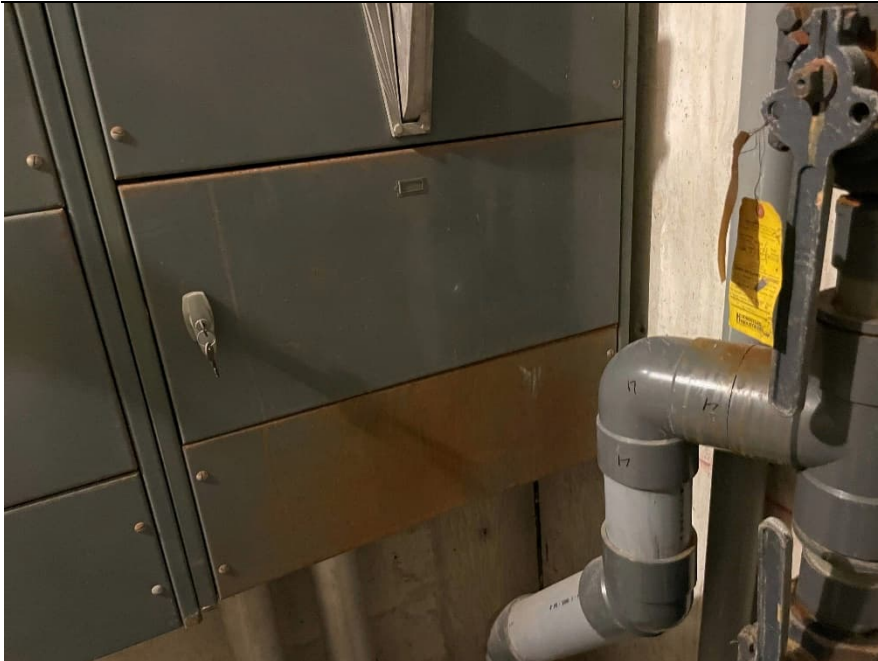
Photo #11:

North Electrical/Meter Room – Bottom face plate of Switch Gear (Main Front + South) is severely rusted. Replacement required.

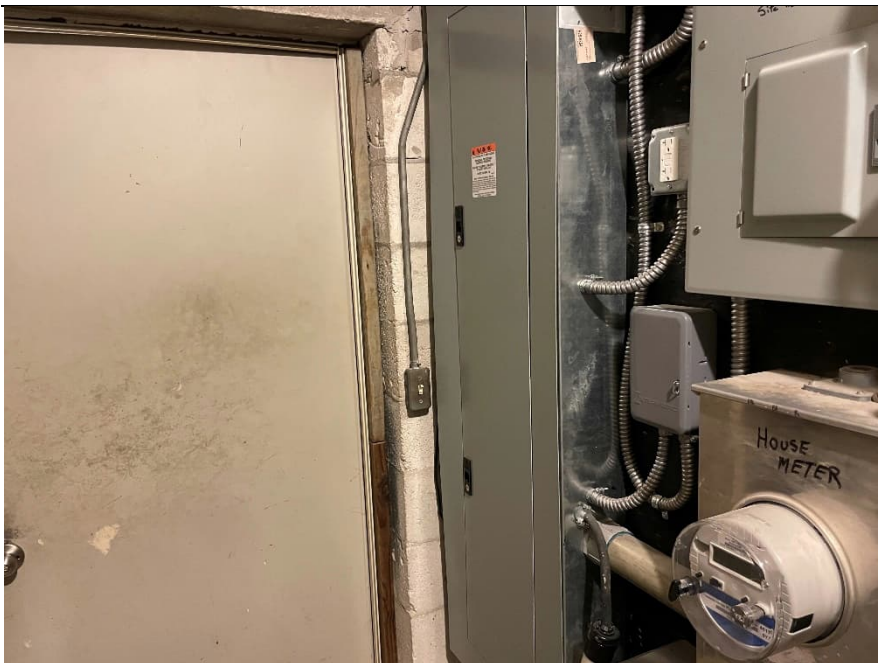
Photo #12:

North Electrical/Meter Room – Distribution house panel needs to be labeled.

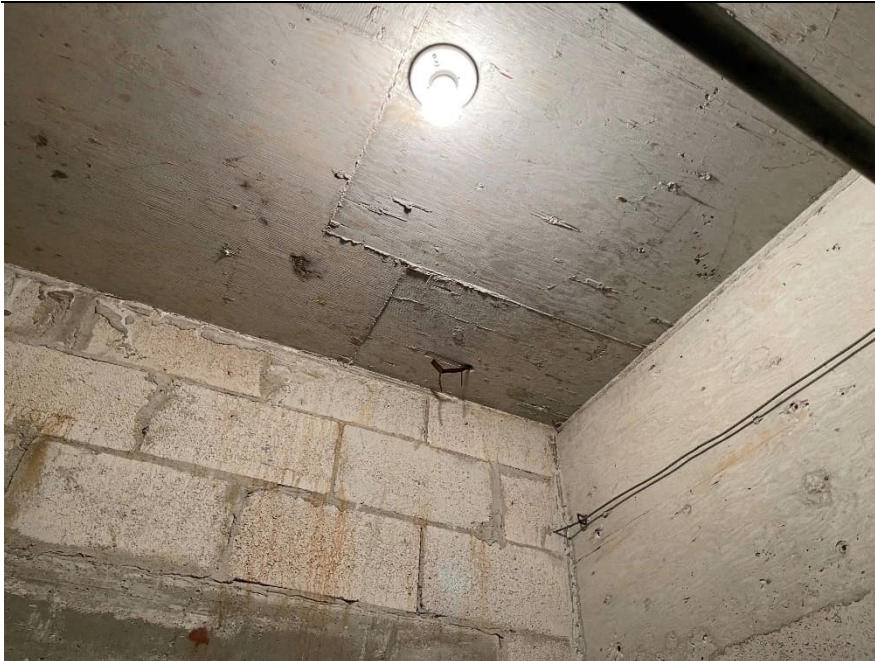
Photo #13:

North Elevator Machine Room – Install smoke detector connected to the existing fire alarm system.

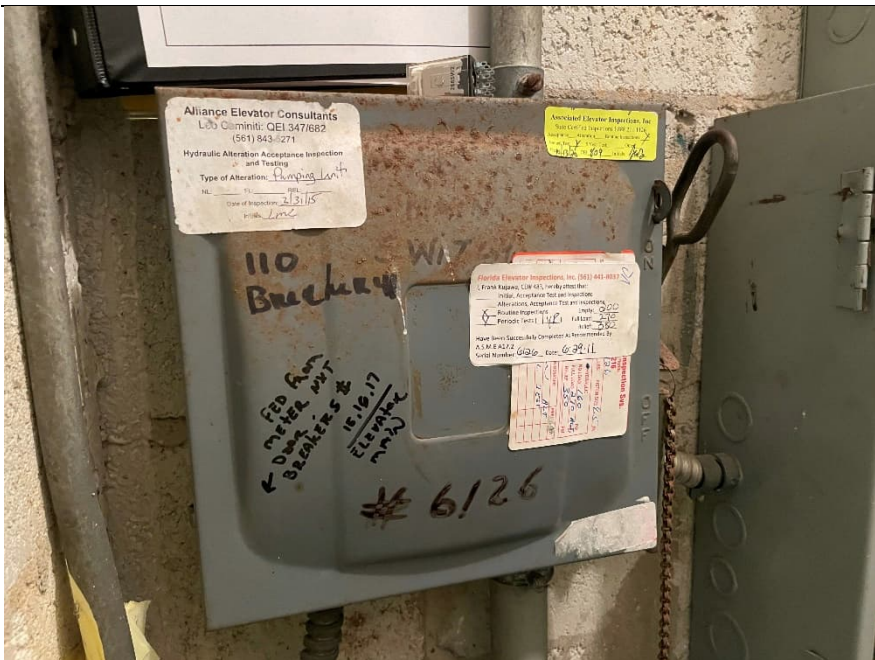
Photo #14:

North Elevator Machine Room – Rusted Zinsco Disconnect Switch should be replaced.

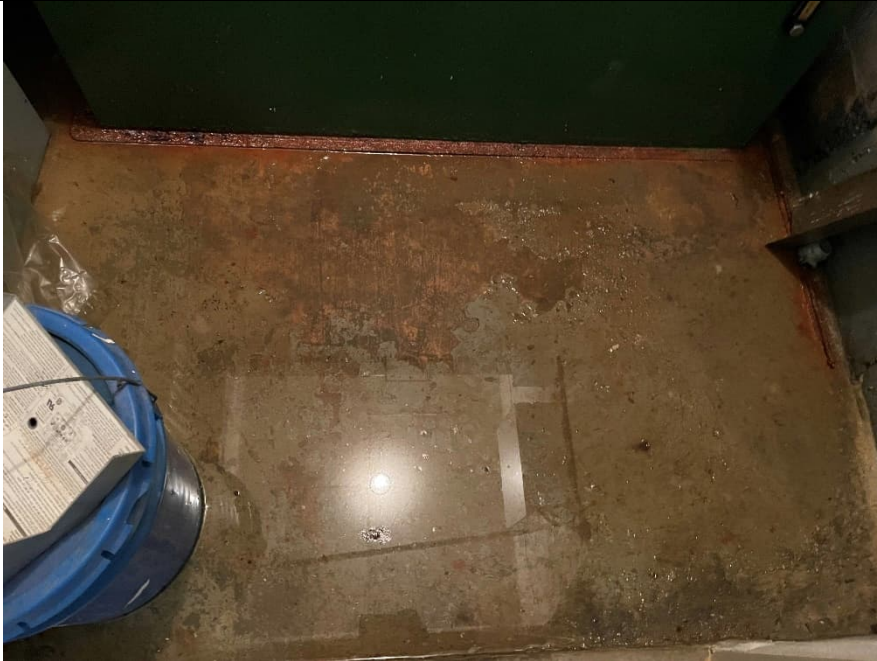
Photo #15:

North Elevator Machine Room – Water on floor. Needs to be clean and dry all the time. Elevator motor is leaking oil and needs identification.

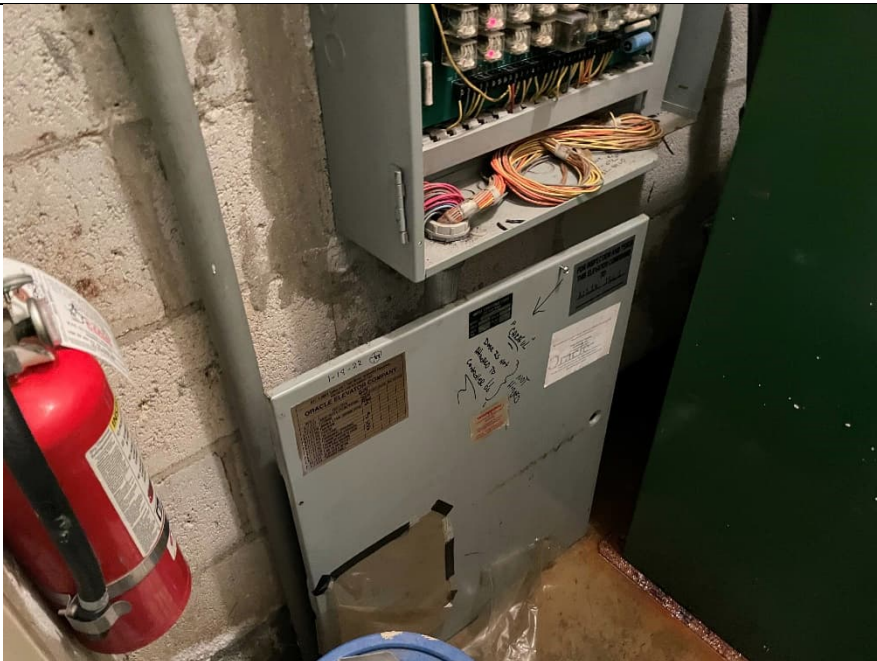
Photo #16:

North Elevator Machine Room – Elevator control box must have the door properly set, not sitting on floor. Elevator control box needs to be labeled.

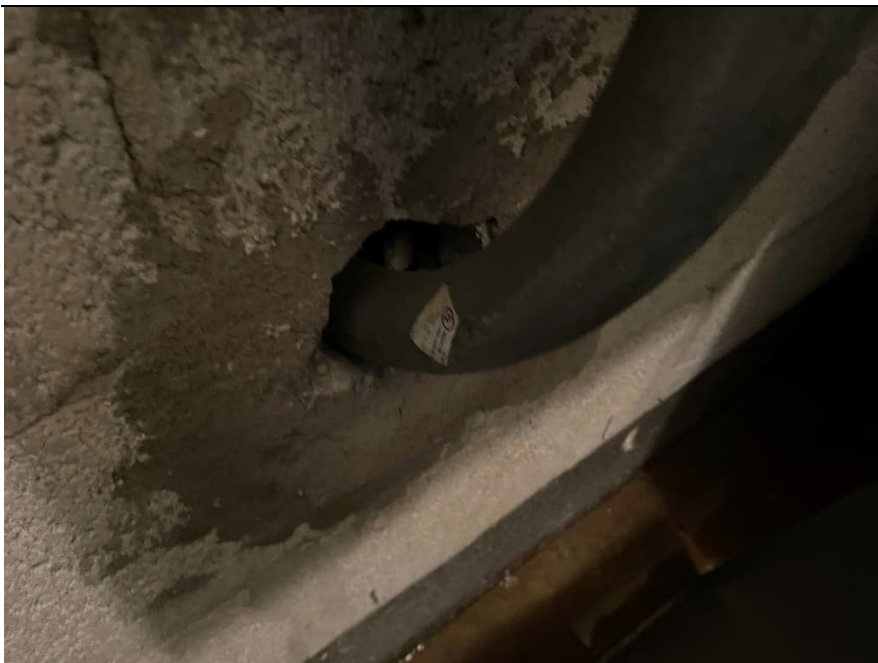
Photo #17:

North Elevator Machine Room – Fire caulks all penetrations at walls & ceiling.

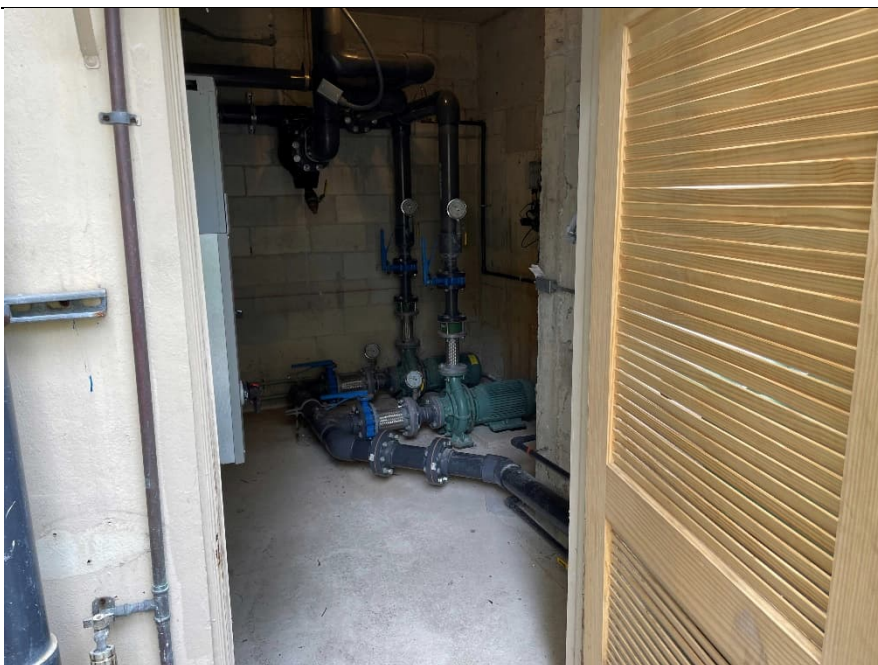
Photo #18:

Pump Room needs to be labeled. Install smoke detector connected to the existing fire alarm system.

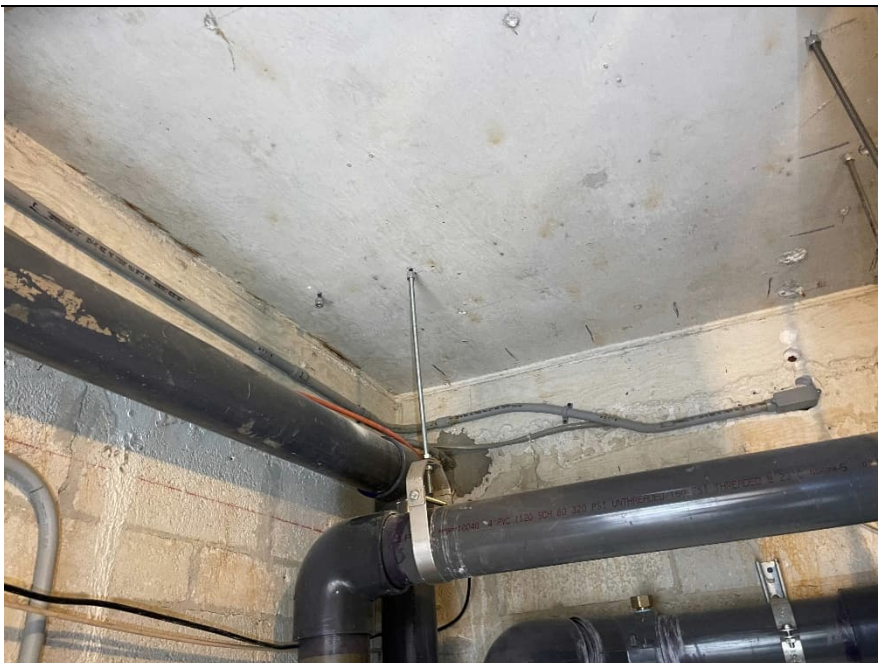
Photo #19:

Pump Room – Fire caulks all penetrations at walls & ceiling.

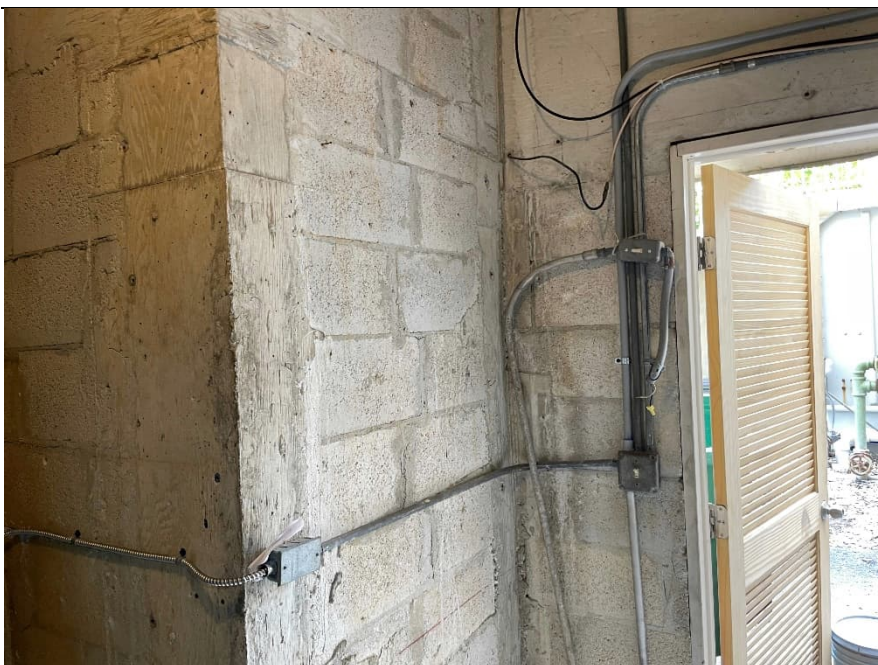
Photo #20:

Pump Room – Replace rusted light switch box. Properly close the open junction box and conduit by the light switch box.

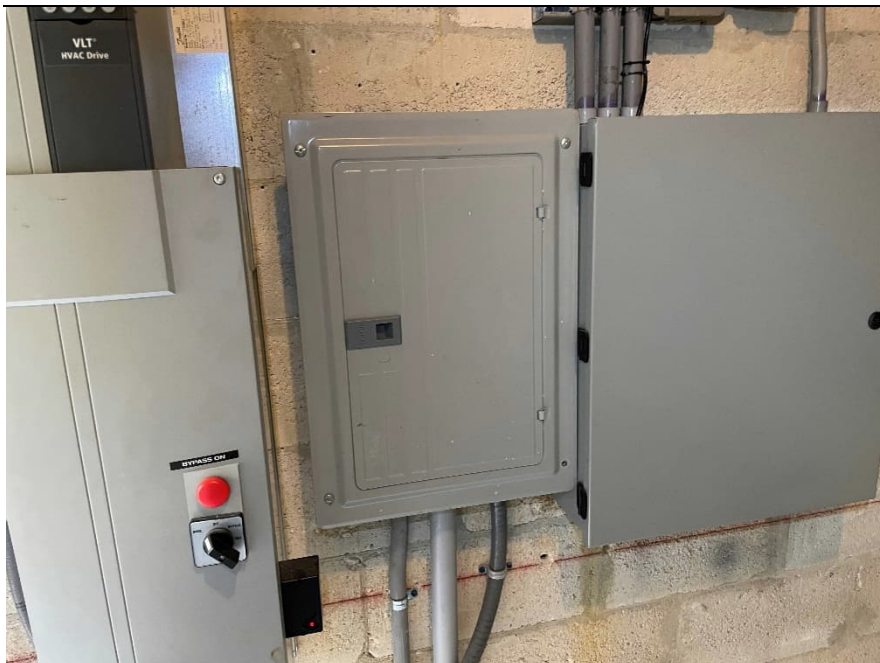
Photo #21:

Pump Room – All panels need to be labeled.

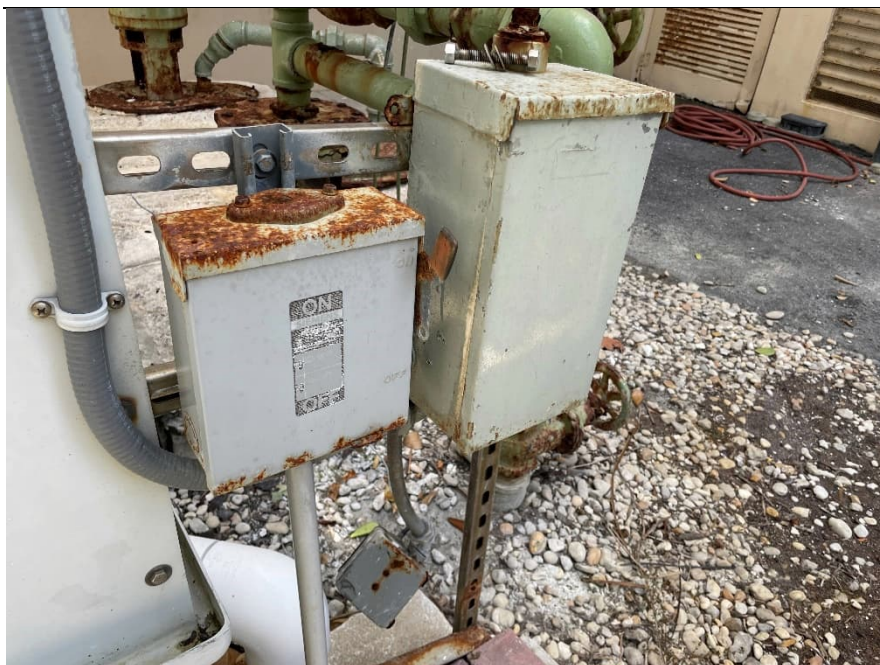
Photo #22:

Condenser Unit –  
Disconnect switch boxes  
severely rusted should be  
replaced. Junction box  
should be properly secure.

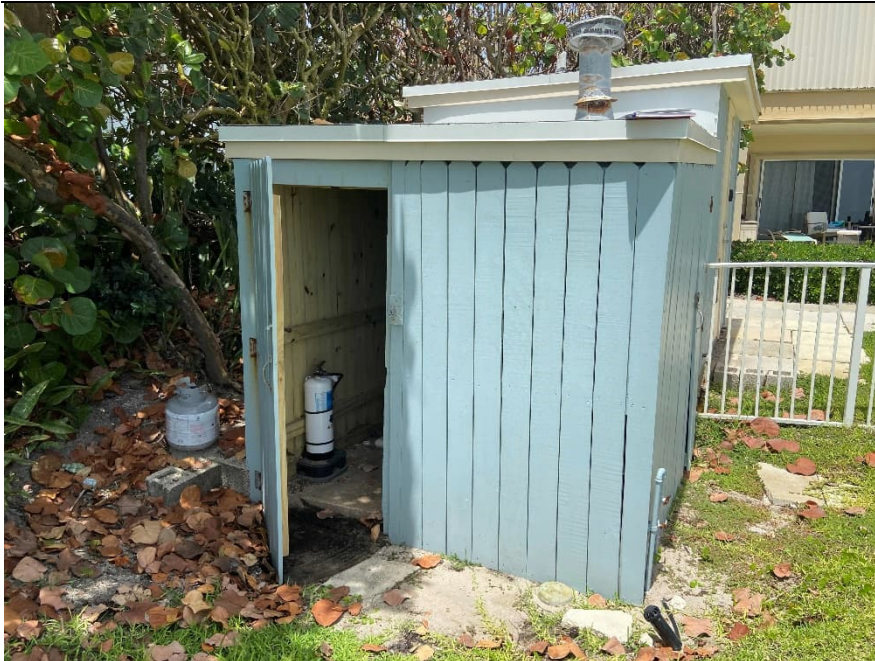
Photo #23:

Pool Pump Room – Room needs to be labeled.

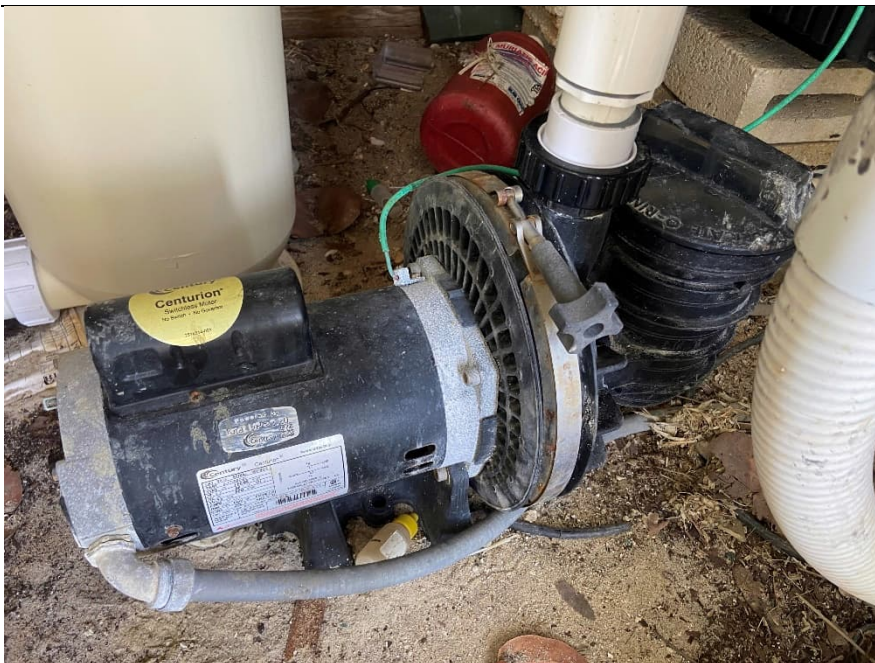
Photo #24:

Pool Pump Room – Pool pump is weatherized, needs maintenance. Pool pump needs to be labeled.

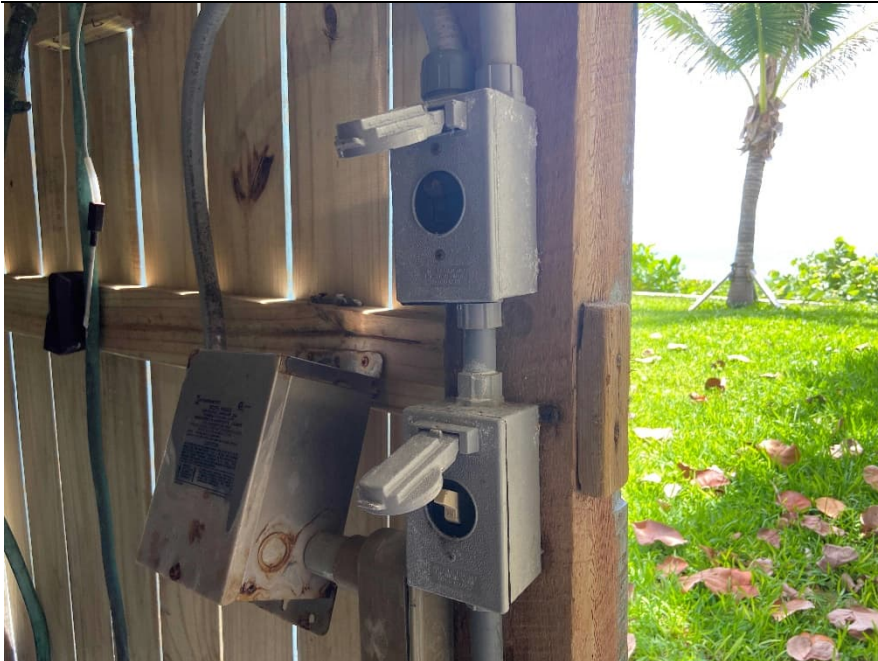
Photo #25:

Pool Pump Room – Pool pump disconnect switch is rusted and needs to be labeled, should be replaced. Conduits are rusted, should be replaced.

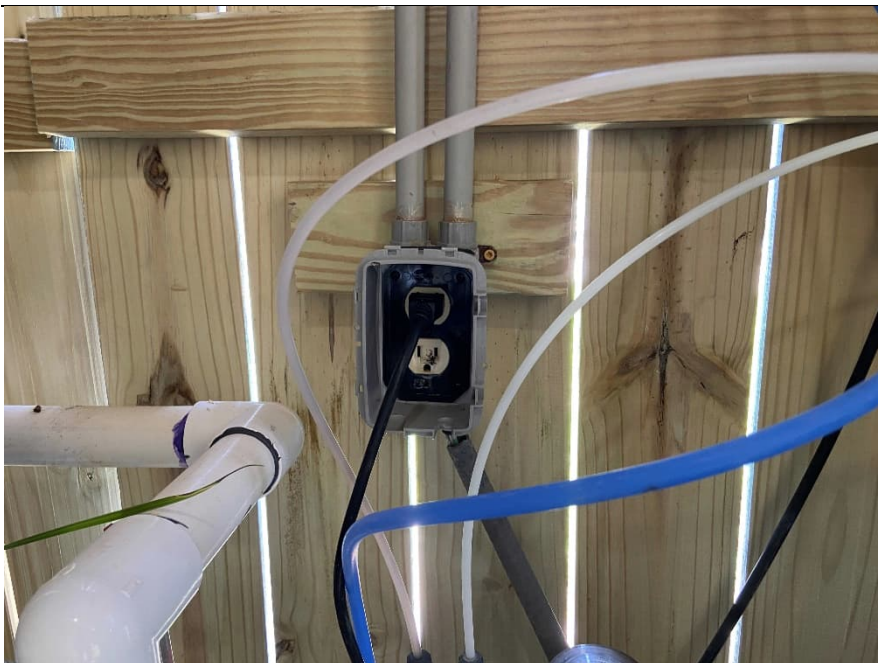
Photo #26:

Pool Pump Room – Replace outlet to be GFCI and with weatherproof cover.

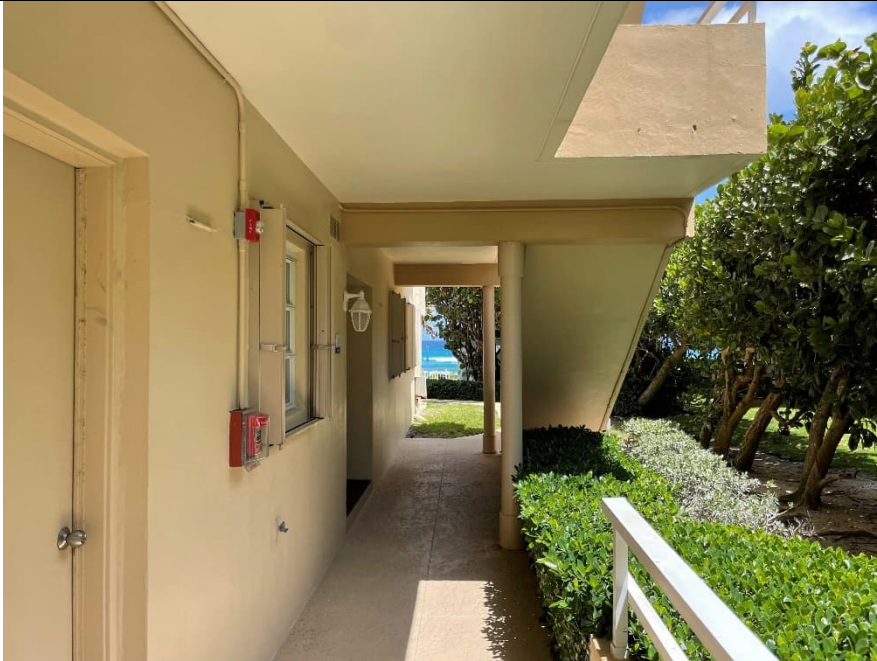
Photo #27:

1<sup>st</sup> floor South Stairs – Pull station and fire alarm horn/strobe hidden by window shutter frame system. In addition, it's located more than 5 feet from exit stairs. Relocation required.

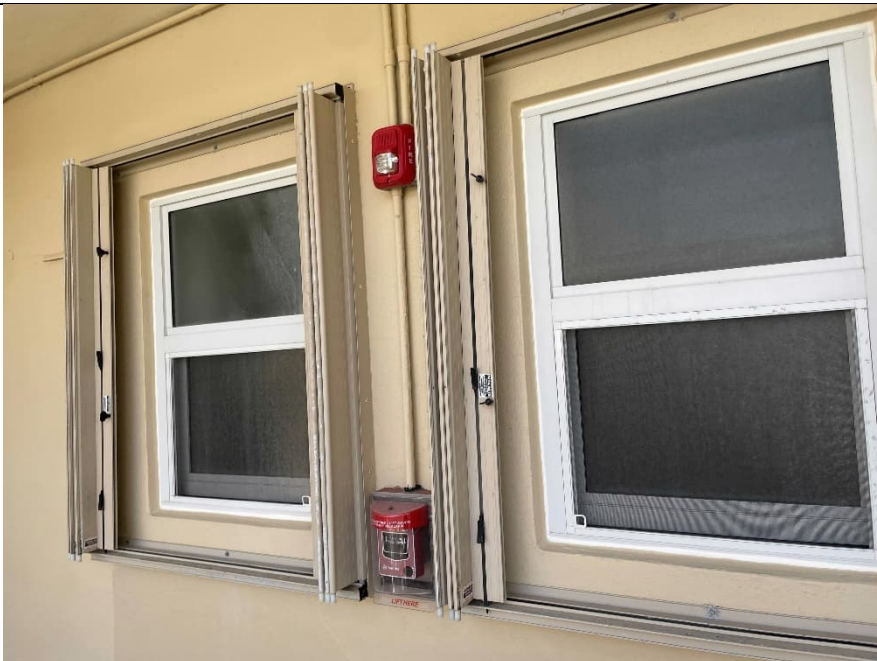
Photo #28:

2<sup>nd</sup> floor North Stairs – Pull station and fire alarm horn/strobe hidden by window shutter frame system. In addition, it's located more than 5 feet from exit stairs. Relocation required.

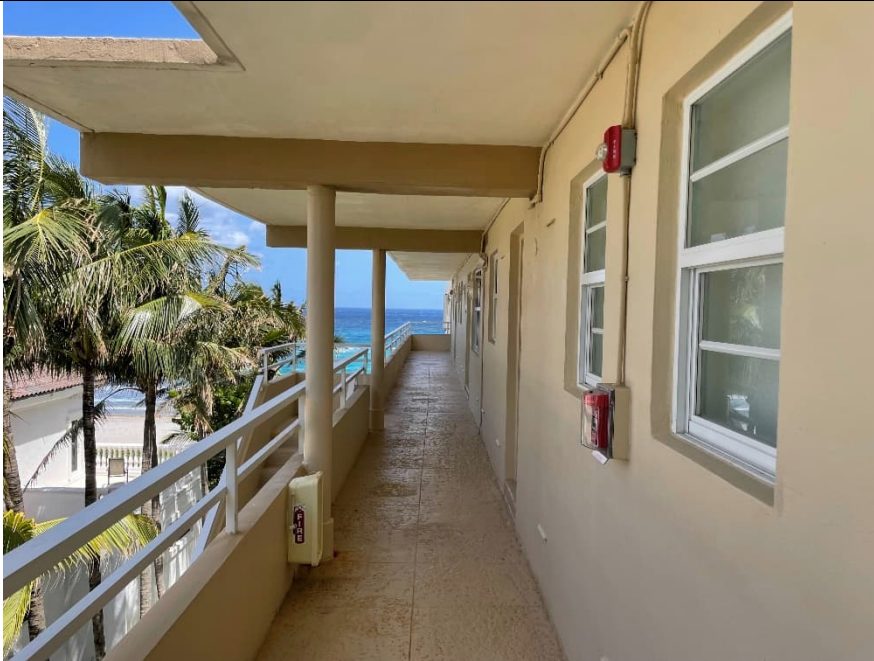
Photo #29:

4<sup>th</sup> floor North Stairs – Pull station and fire alarm horn/strobe located more than 5 feet from exit stairs. Relocation required. All pull stations and fire alarm horn/strobes should be located within 5 feet of exit stairs on every floor.

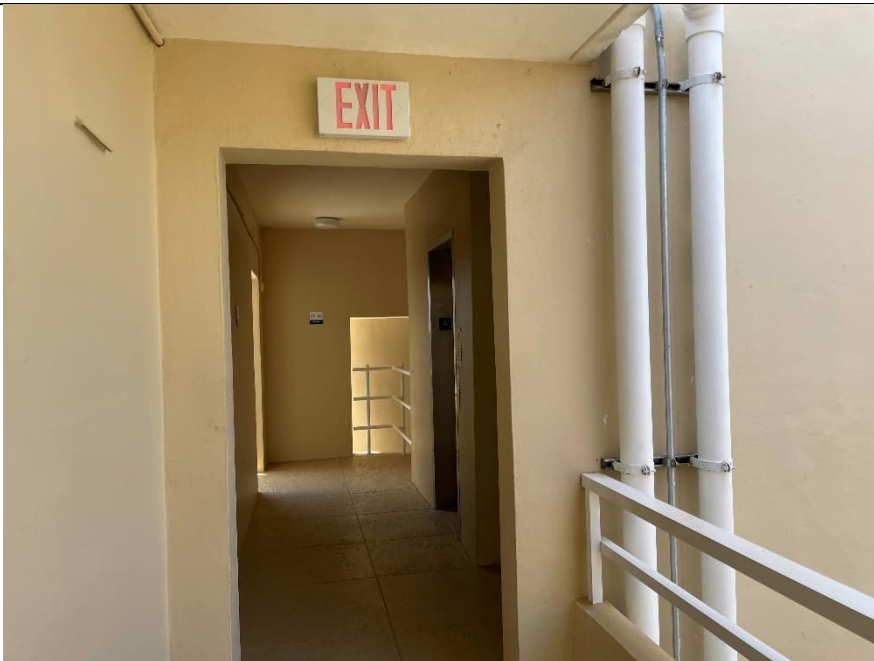
Photo #30:

4<sup>th</sup> floor North Elevator Lobby/Stairs – North Entrance Pull station and fire alarm horn/strobe should be installed, or the existing Pull Station and fire alarm horn/strobe at South Entrance should be relocated within 5 feet of exit stairs on every floor. In addition, exit sign should be replaced and emergency lights should be installed on every floor.

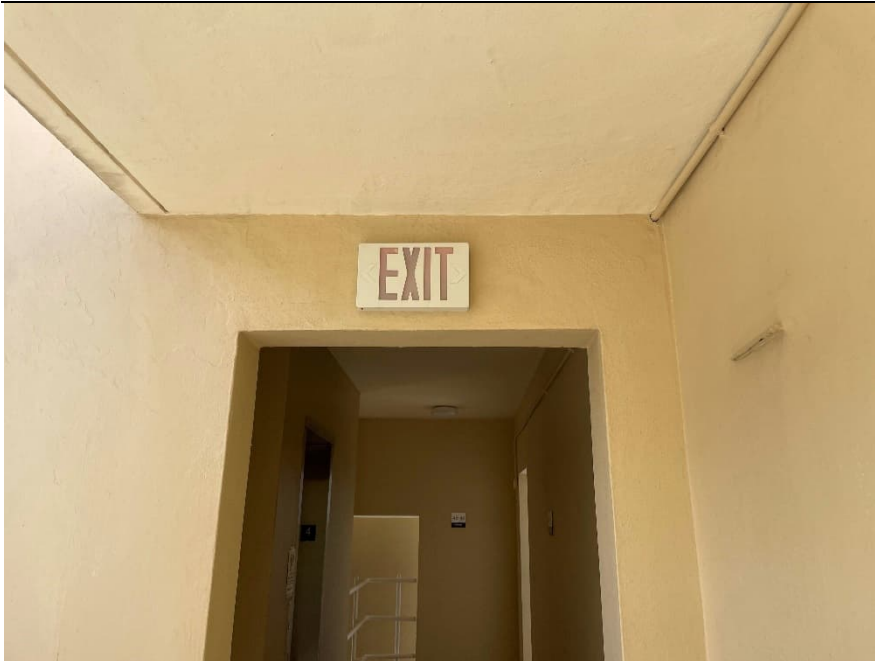
Photo 31:

4<sup>th</sup> floor South Elevator Lobby/Stairs – South Entrance Pull station and fire alarm horn/strobe should be installed, or the existing Pull Station and fire alarm horn/strobe at North Entrance should be relocated within 5 feet of exit stairs on every floor. In addition, exit sign should be replaced and emergency lights should be installed on every floor.

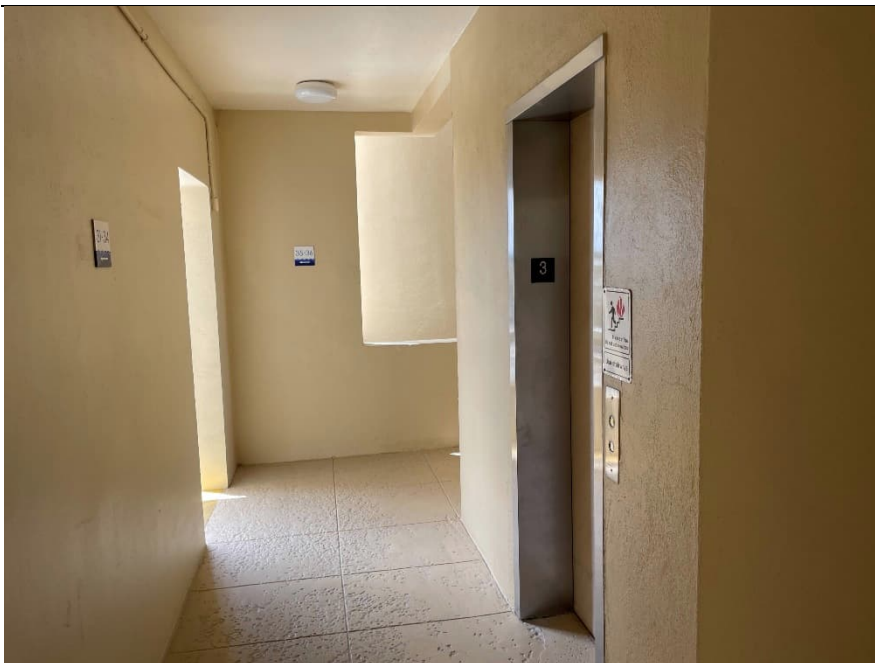
Photo #32:

3<sup>rd</sup> floor North Elevator Lobby/Stairs – Smoke detector should be installed on elevator lobbies on every floor.

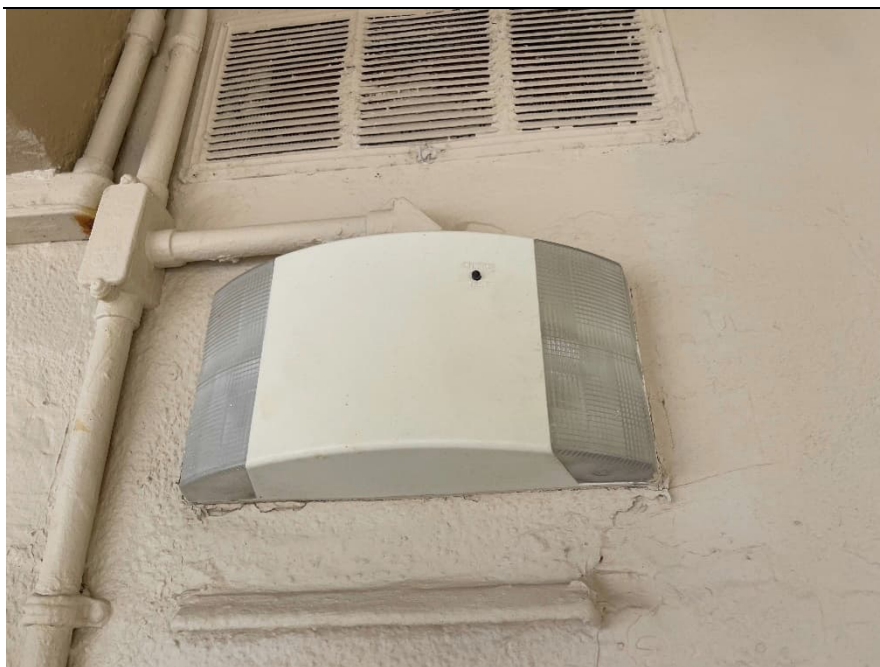
Photo 33:

3<sup>rd</sup> floor North Stairs –  
Emergency light  
weatherized and not in  
working condition.  
Replacement required.
